Riverfront Parks Committee

May 11th, 2022

US Army Corp of Engineers

Ecosystem Restoration

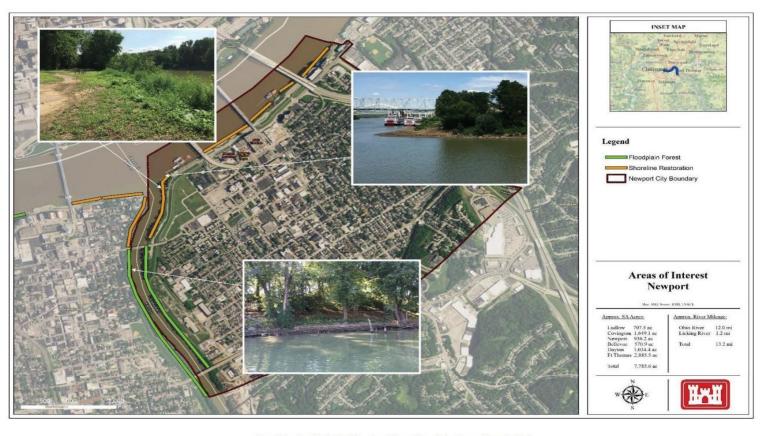
Figure 15. Location of Restoration Alternatives in Newport (Levee System is present along shoreline).

Newport: covers approximately 6,100 linear feet of shoreline and 3 acres, including 2,700 linear feet of floodplain forest along Newport's Ohio River and Licking River.

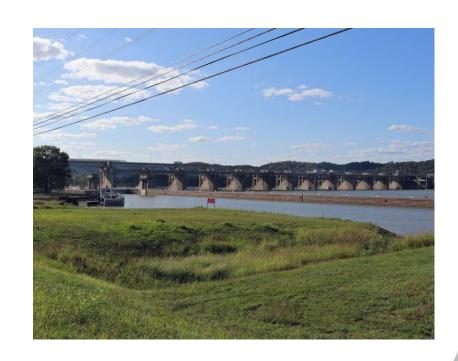
Markland Locks and Dam

Began Operation in 1959.

Has a lock lift of 35 feet and maintains a minimum navigation pool at elevation 455 North American Vertical Datum of 1988 (NAVD88) for a length of some 93 miles of the Ohio River.

The navigation pool was increased by 14 feet along the Ohio River.

Eliminated the need for five existing low lift lock and dams in the system.

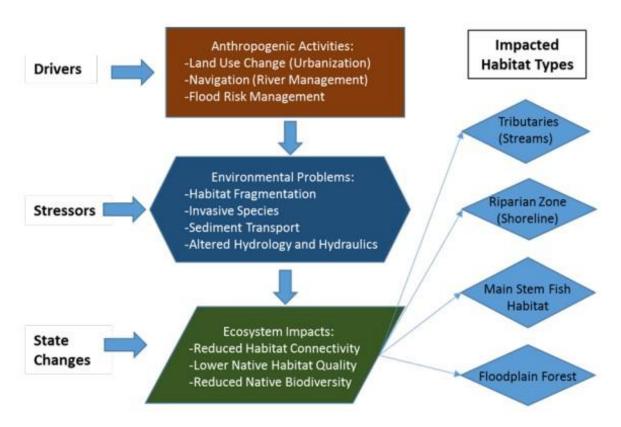
Conceptual Ecosystem Model for Study Area

Figure 10. Conceptual Ecosystem Model for Study Area.

Conceptual models are descriptions of the general functional relationships among essential components of an ecosystem: they tell the story of how the system works.
